## Wet Floodproofing Reduces Damage to Popular Beach Restaurant

### Full Mitigation Best Practice Story

#### *Monroe County, Florida*

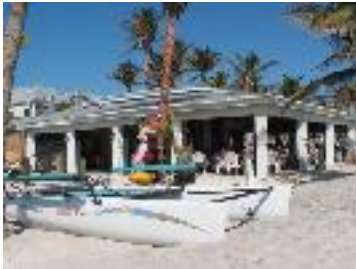
The wide-open design of the Duval Beach Club

The concept of wet floodproofing is simple: provide means to allow floodwaters to enter, flow through, and exit a building, thereby preventing more severe damage to the building as a whole. Non-absorbent materials and/or coatings are used to allow easier cleaning and sanitizing of interior surfaces after a flood event.

"Utilizing the old wall structure, we opened it up a little bit more, so we'd be able to get better penetration for water," Mr. Tillman said. "The center wall is a break away wall, so if we really have big water, it would just push out."

The walls for the restrooms, which are perpendicular to the ocean, are poured concrete and anchored to the concrete slab. The walls facing the ocean are designed to break away when inundated by storm surge. Another mitigation measure was to elevate the electrical system. Wiring runs from the top of each wall down to the outlets, which are elevated 42 inches from the floor. Extra wiring coiled at the top of the walls can be pulled down for use after flooded outlets are cleaned and damaged wiring removed.
